Unusual Foreign Bone Fragment in Femoral Open Fracture

Hanon Sadoni^{1,*} and Hamidreza Arti¹

¹Department of Orthopedic Surgery, Ahvaz Jundishapur University of Medical Sciences (AJUMS), Ahvaz, IR Iran

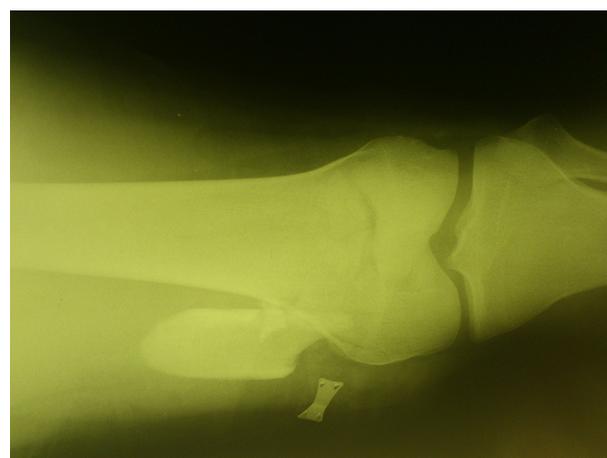
Figure 1. Antero-Posterior View of Femoral Segment

A femoral shaft fracture with a large segment was seen in AP (Figure 1) and laterl view (Figure 2).

Right humerus open fracture, right forearm fracture, right distal radius fracture, a femoral shaft fracture with a large segment was seen in AP (Figure 1) and laterl view (Figure 2) and right multiple metatarsal fractures.

The femoral shaft fracture was in the middle third, with some comminutions. But a large butterfly fracture was also seen in X-ray. According to the initial evaluation and wound condition, the open fracture was a Gustilo Type II. We usually start antibiotics and tetabuline routinely in the emergency department, but do not send culture samples from the open fracture site.

This butterfly was in the posterior aspect of the thigh; its lumen was facing posteriorly and had a distance of about 12 - 15 cm from the fracture site. A 5 - 6 cm laceration was seen on the posterior surface of the thigh.

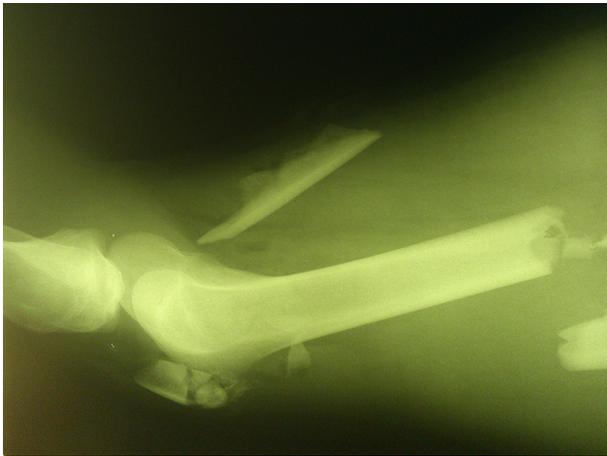
Figure 2. Lateral View of Femoral Segment
